Avondale Estates Stormwater Master Plan

Prepared for
City of Avondale Estates
Avondale Estates, Georgia
February 19, 2021

FINAL

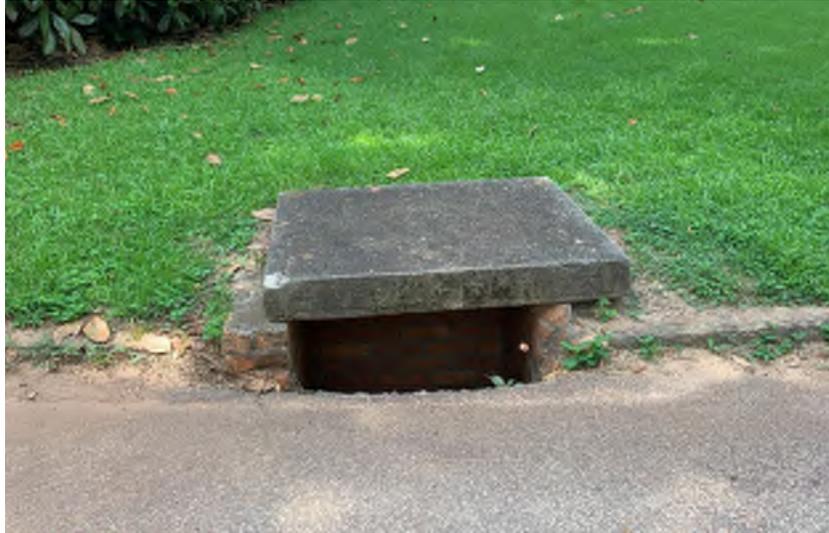
Figure 3-4. Example of stormwater structure with no access port

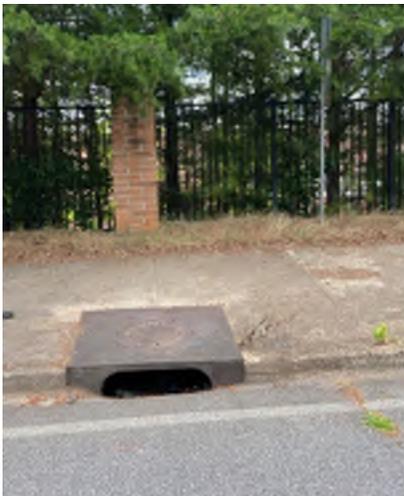
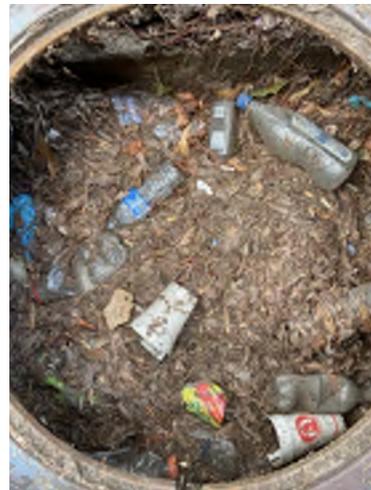
After reviewing top scoring stormwater assets, it was determined that siltation and significant debris accumulation was a systematic issue that impacted many of the top scoring stormwater assets. Figure 4-1 shows an example of a stormwater asset located in the City that is impacted by significant accumulation of sediment and debris.

Figure 4-1. Example of stormwater asset with high siltation score

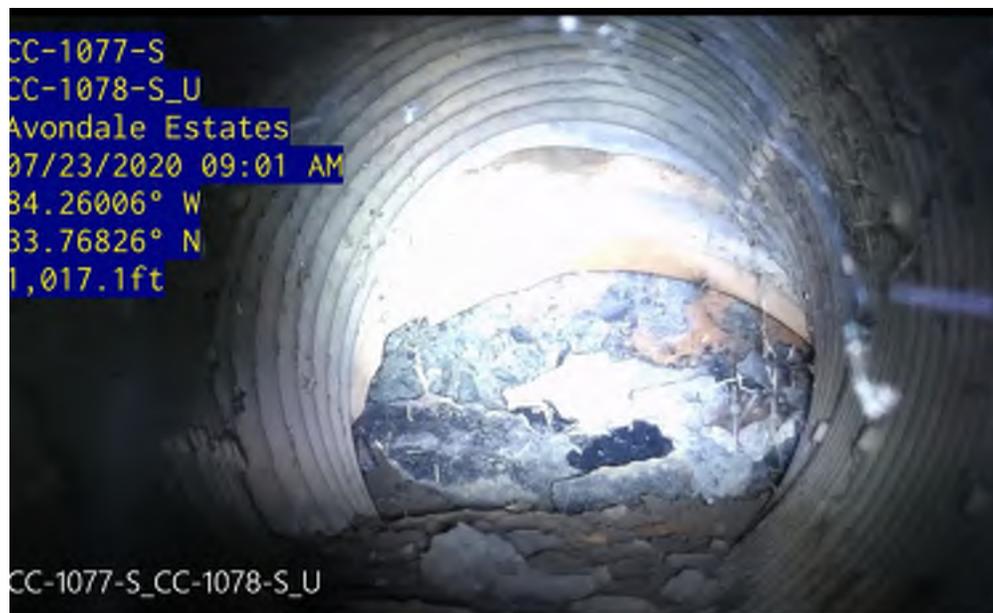
Stormwater asset CC-4072-C is a pipe located under Majestic Circle which had the fourth highest prioritization score. One of the key drivers for the high score is due to a collapse in the pipe (Figure 4-2). The proposed concept plan for this site includes replacement of the pipe under Majestic Circle and additional segments downstream for a total pipe replacement length of approximately 280 feet. In addition, the project includes installation of curb at strategic locations along the east side of Majestic Circle to guide stormwater flow, and improvements to the downstream open channel conveyance. Refer to Appendix D for the plan view sheet of this concept which lays out more specifics on improvements proposed for this site. The estimated cost for this project is \$265,000.

Figure 4-2. Interior view of CC-4072-C under majestic circle

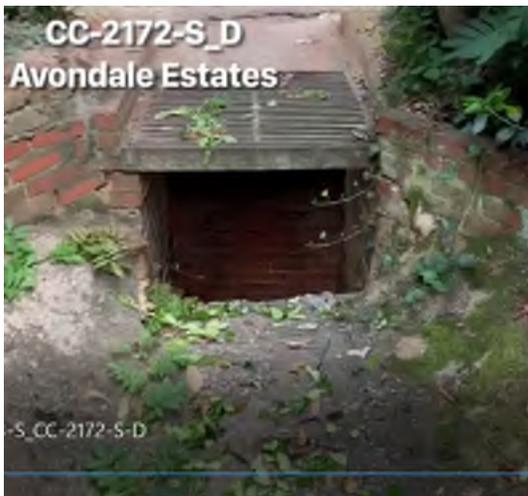
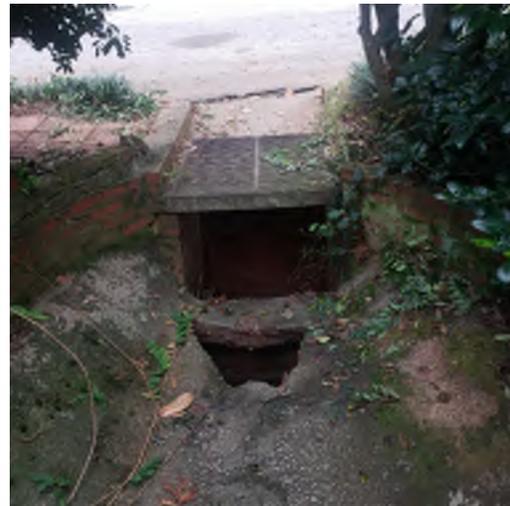
Three stormwater conveyances (CC-4147-C, CC-4317-C and CC-4316–C) in this area are in the top ten of scored stormwater assets. Also, this area received one of the highest ratings during the community feedback survey (Figure 3-3). Most of the feedback indicated that portions of the stormwater infrastructure are in poor condition and that flooding occurs. During the development of the SWMP a sink hole developed in the concrete flume CC-4317-C (Figure 4-3)

Figure 4-3. Sink hole at downstream end of concrete flume (CC-4317-C) at Dunwick Drive

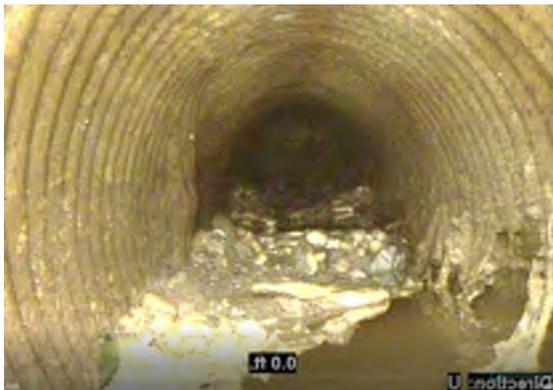
The project area for Concept #4 is located at the intersection of Washington and Pine Street in downtown. Based on field inventory observations, structure SF-1273-S along with adjacent pipes were included as part of the stormwater asset cleaning and closed-circuit television (CCTV) that was completed as part of Concept #1. Based on the CCTV inspection, the downstream pipe in this system, SF-4567-C, is a 24-inch CMP pipe which appears to be collapsed. As shown in Figure 4-4 the CCTV crawler could not traverse the length of the pipe from the downstream or upstream approach.

From upstream end, pipe appears collapsed since debris from cleaning process cannot move downstream

Figure 4-4. Collapsed pipe SF-4567-C at Washington Street

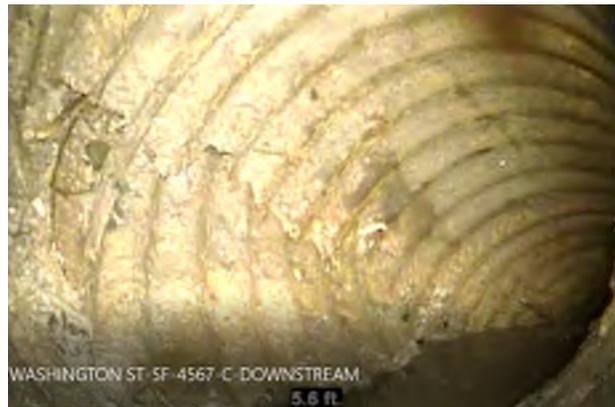
From downstream end, some water from cleaning process gets through the pipe. TV crawler could move no further upstream due to constricted size of pipe.

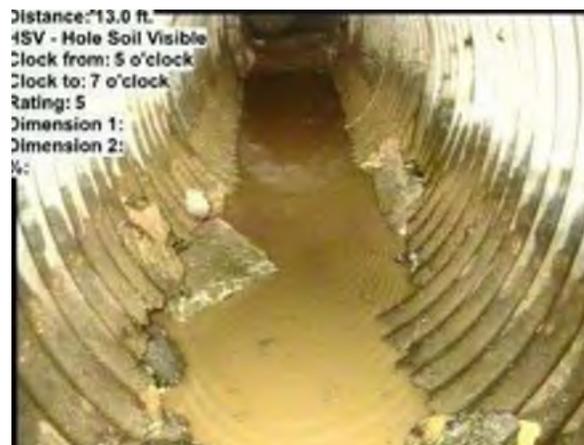
The project area for Concept #5 is located on Kensington Road. The bulk of the project is located in the road right-of-way but will also include impacts at 3218 and 3221 Kensington Road. Based on the field inventory of stormwater assets, three pipes segments at this location (CC-4235-C, CC-4004-C, and CC-4005-C) were included as part of the Concept #1 which included cleaning and CCTV. Once clean, the video of these pipes revealed that the bottom of the pipe was missing for much of the pipe length (Figure 4-5).

Figure 4-5. Missing bottom at pipe CC-4004-C at Kensington Road

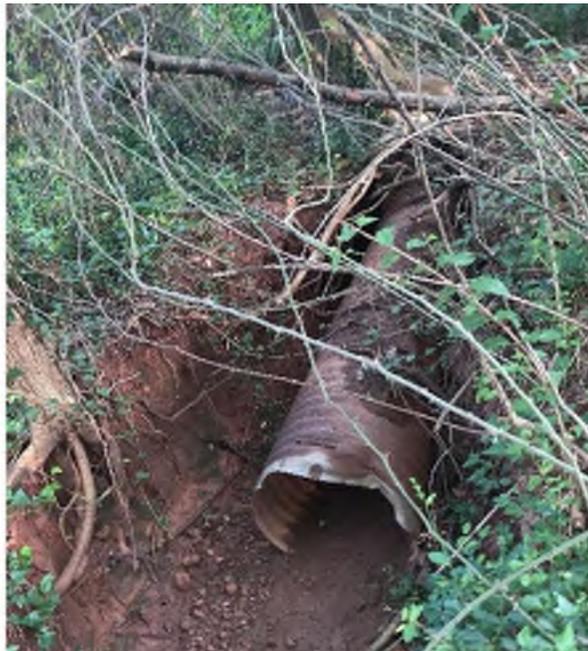
Pipe IC-4340-C is located at 177 N Clarendon Avenue on property owned by the Metropolitan Area Rapid Transit Agency. This pipe does not have a headwall at the end, much of the bottom has rusted through and the soil near the pipe has been washed away via erosion (Figure 4-6).

Figure 4-6. Downstream end of pipe IC-4340-C near N Clarendon Road

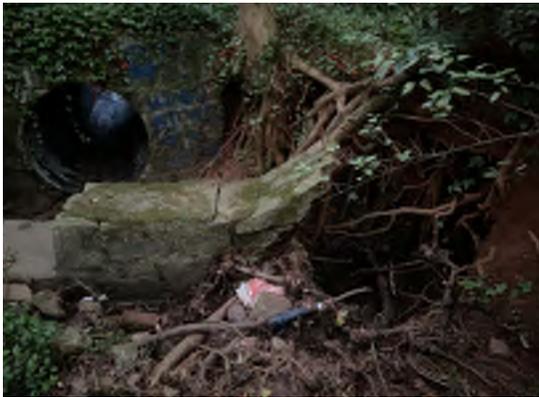
Stormwater structure CC-2160-S scored in the top ten. This score was driven by a stone weir that is located adjacent to the structure has experienced significant erosion and is being undermined (Figure 4-7). Another top scoring asset in this area is CC-4305-C. This 30-inch CMP is located under Wiltshire Drive near the intersection of Lakeshore Drive. As shown in Figure 4-7 much of the bottom of the pipe is gone and soil and roots are visible.

Erosion at CC-2160-S

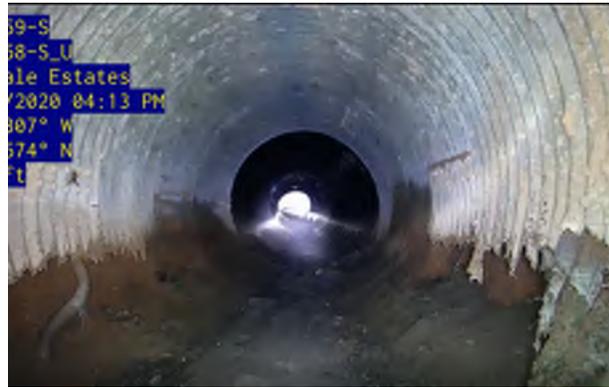
Missing pipe bottom at CC-4305-C

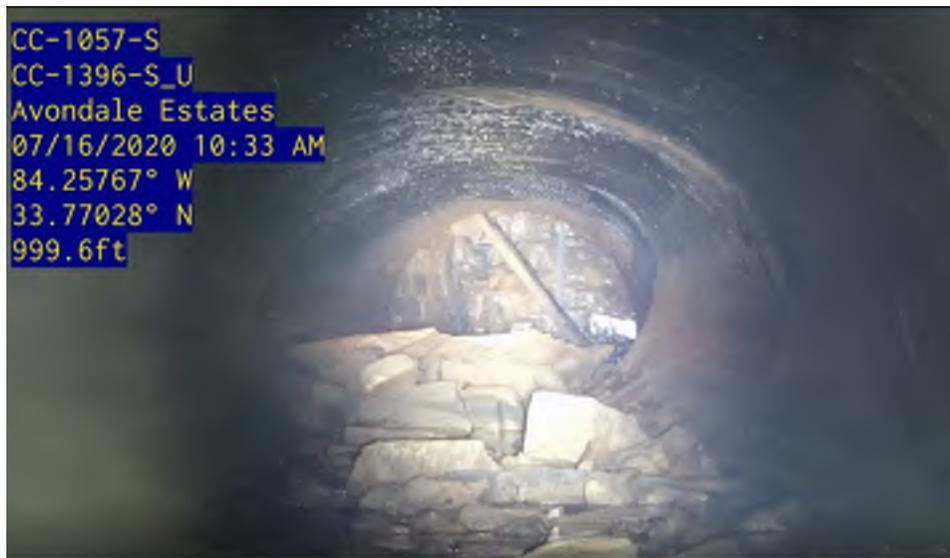
Another top scoring stormwater asset is CC-4052-C which is located under Majestic Circle between Wynn Drive and Nottingham Drive and conveys Cobbs Creek. This pipe is deformed and contains large debris (Figure 4-8). In addition, the next pipe downstream, CC-4197-C, also scores high.

Figure 4-8. Interior view of conveyance CC-4052-C

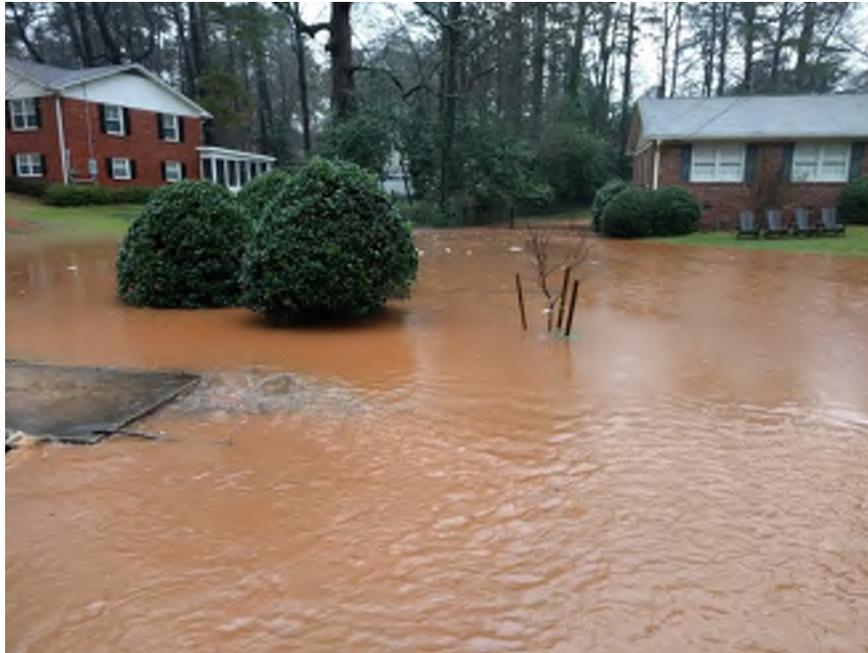
The existing study examined Cobbs Creek from the headwaters down to the confluence with Cobbs Creek Tributary 8 near Memorial Drive. In this study, the system from Kensington Road to Wynn Drive is referred to as pipe system G. The study found that pipe system G is undersized for the 25-year event but that the pipe size may be increased to convey the 25-year event (CPL October 2010). Another evidence of the undersized nature of these pipes was collected during the public feedback period. Figure 4-9 shows flooding that occurs on the downstream end of these high scoring assets near 3210 and 3222 Wynn Drive. Also, it should be noted that the pipe under Wynn Drive was not accessible and as such did not receive a prioritization score.

Figure 4-9. Flooding on Cobbs Creek at north of Wynn Drive

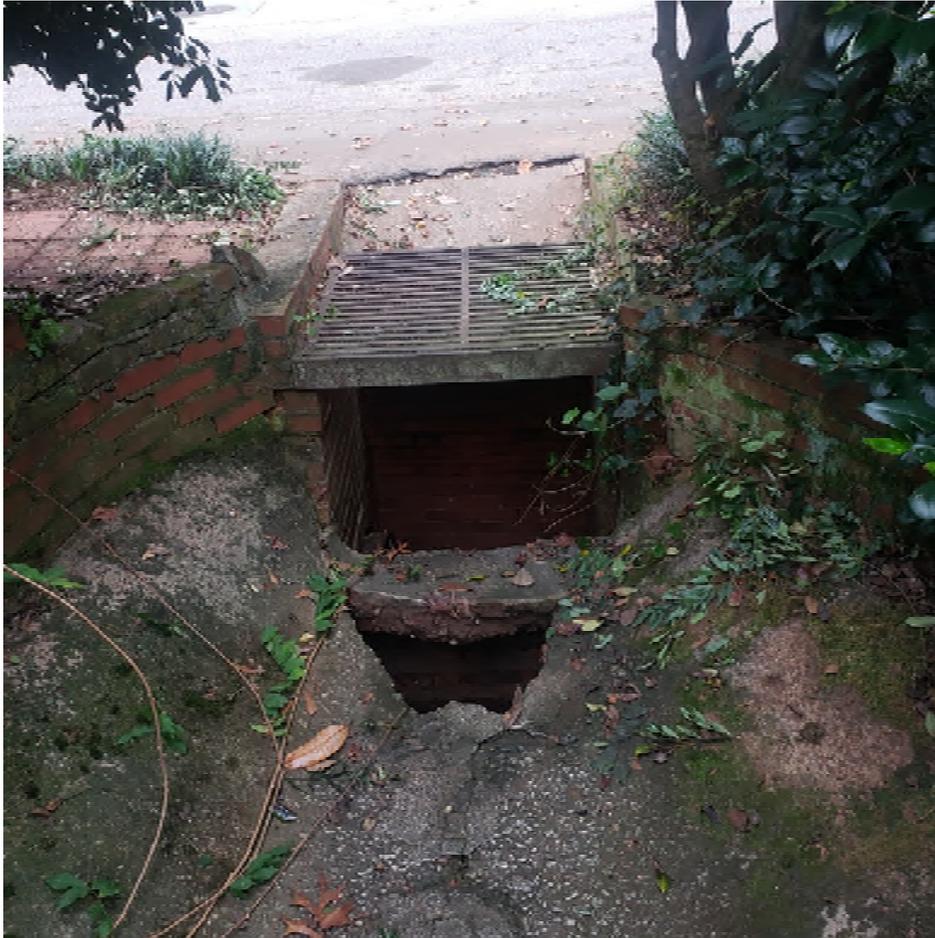
Figure 1. Flume failure (CC-4317-C)

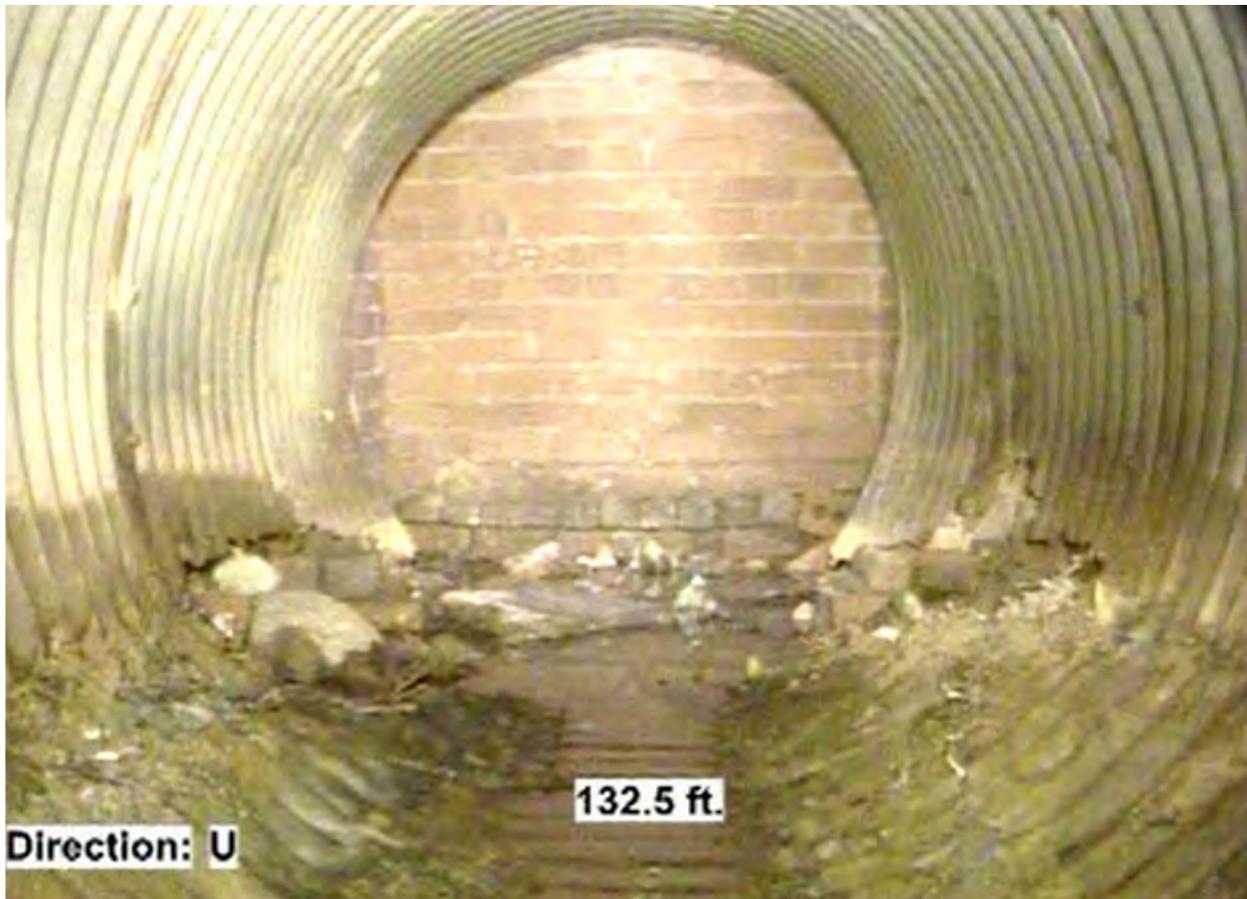
Concerning Asset ID CC-4316-C, the upstream invert of the corrugated metal pipe (CMP) has failed for 10 to 15 feet, refer to Figure 2. In order to provide a temporary repair, it is recommended that a minimum strength grout of 3,000 psi with reinforcement fiber be used to form a new pipe invert in this area. This invert should be poured contiguous with a new invert for structure CC-2172-S. Once the new invert is in place, flowable fill should be used to the extent possible to fill any voids surrounding pipe CC-4316-C or structure CC-2172-S. Pilot holes may be needed to access voids in order to fill with flowable fill.

Figure 2. Failed CMP invert at upstream end of CC-4316-C

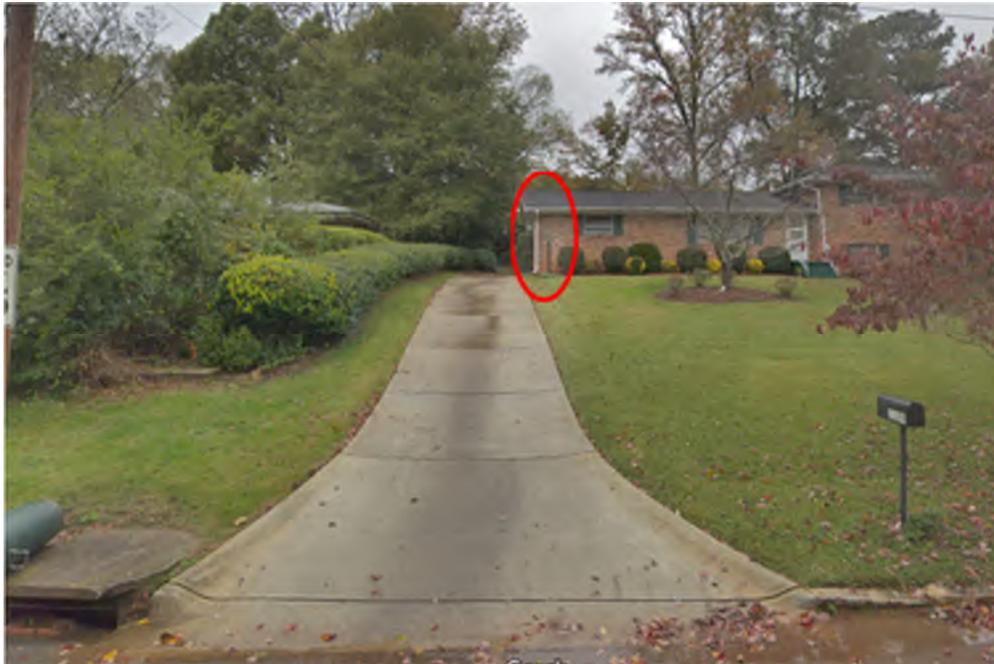
The next step in this analysis is to determine how to provide runoff reduction for the watershed. One way that may work particularly well for this watershed is downspout disconnection. Many of the homes in this watershed have downspouts that drain to a driveway and then directly into the street and storm system (Figure 4).

Figure 4. Example on Chatsworth Drive of a directly connected downspout
