Public Information Meeting for the
Avondale Estates
Stormwater Master Plan

February 3, 2021

Stormwater Master Plan

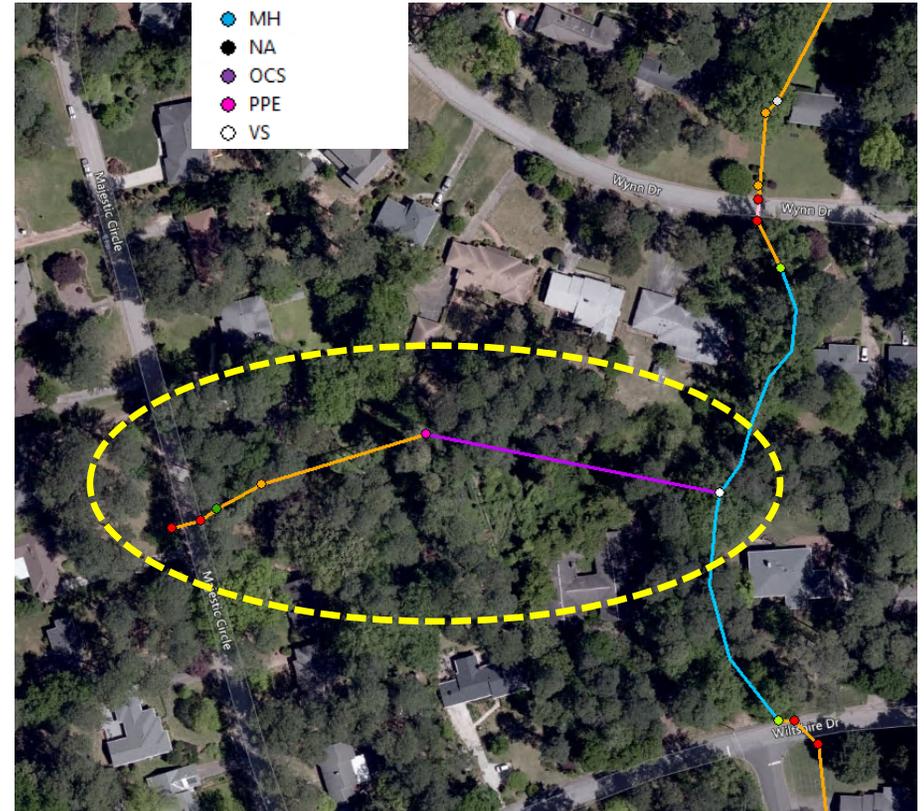
- ▶ Stormwater asset CC-4072-C located under Majestic Circle
 - ▶ Second highest prioritization score
 - ▶ One of the key drivers for the high score is due to a collapsed segment of pipe
- ▶ Plan includes:
 - ▶ Replacement of the pipe under Majestic Circle and additional segments downstream for a total pipe replacement length of approximately 280 feet.
 - ▶ Installation of curb at strategic locations along the east side of Majestic Circle to guide stormwater flow
 - ▶ Improvements to the downstream open channel conveyance.

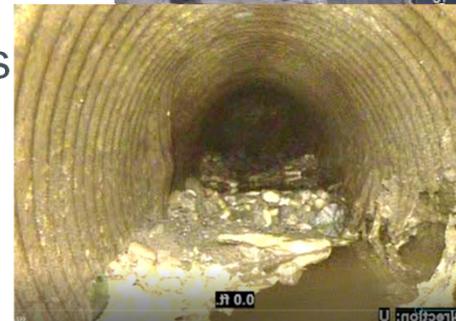
From upstream end, pipe appears collapsed since debris from cleaning process cannot move downstream

1. Replace/CIPP the pipes and maintain the current pipe size and design GI to detain stormwater volumes so that pipes may meet the desired return interval capacity
2. Develop a stormwater model for the entire drainage system flowing to the project area, determine the size of pipes needed to convey desired return interval, and confirm no downstream impacts.

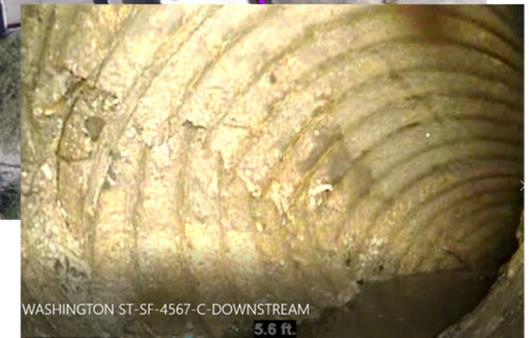
From downstream end, some water from cleaning process gets through the pipe. TV crawler could move no further upstream due to constricted size of pipe.

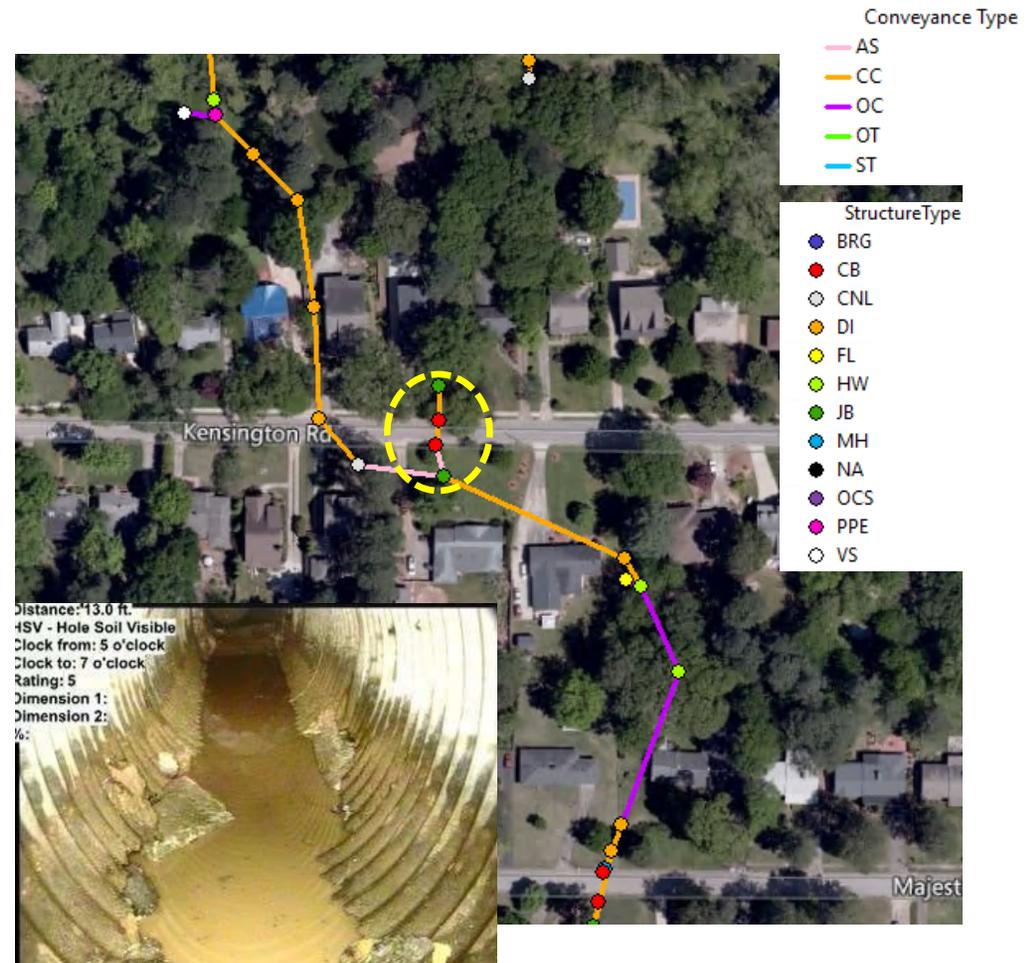
Missing Bottom at Pipe CC-4004-C at Kensington Road

- ▶ Proposed improvements include:
 - ▶ Abandon CC-4235-C in place and fill with flowable fill (north side of Kensington Road)
 - ▶ Remove and replace CC-4004-C, and CC-4005-C with concrete pipe
 - ▶ Replace structure CC-1008-S, located on the south side of Kensington
 - ▶ Add risers to enable structure access for structure CC-1050-S, located at 3221 Kensington, which is currently buried

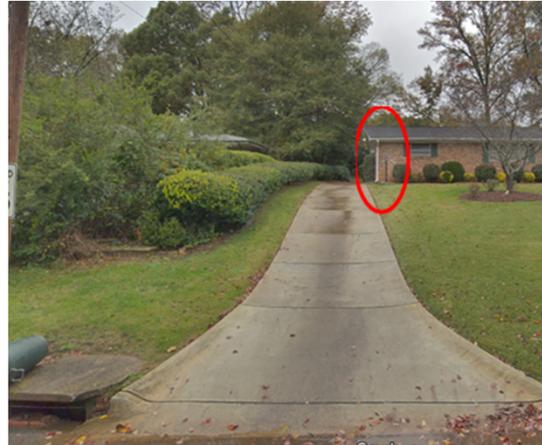
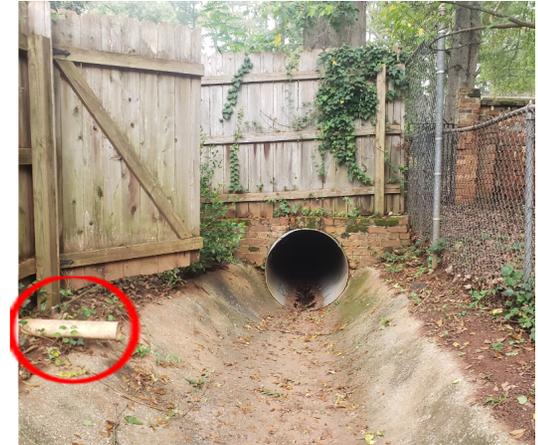
Examples of Directly Connected Impervious

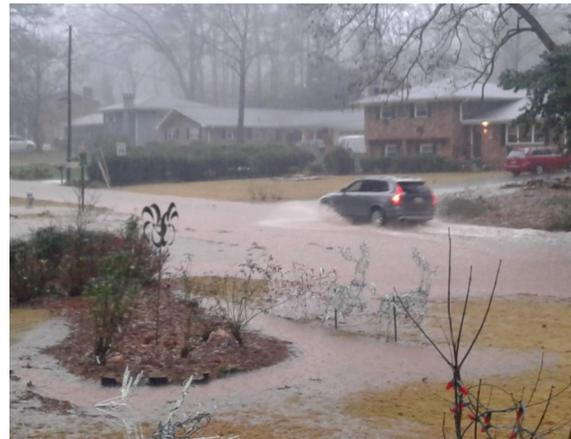
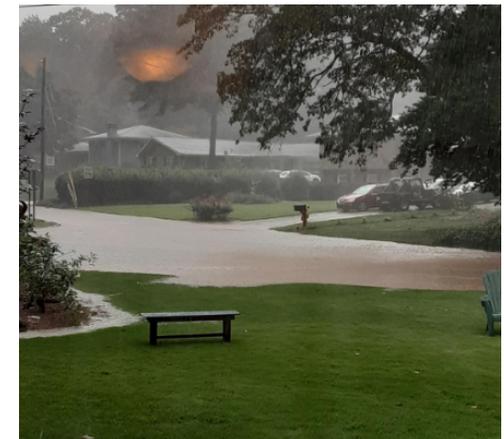
Downstream impact of Directly Connected Impervious
