Public Information Meeting for the
Avondale Estates
Stormwater Master Plan

February 3, 2021

Stormwater Master Plan

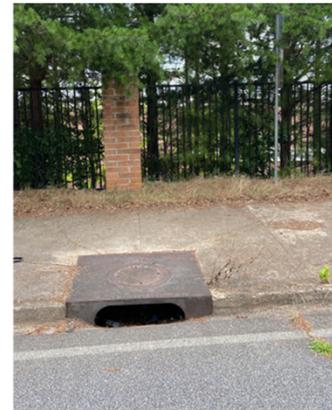
Exterior View

- ▶ Review of all stormwater assets with a 4 or 5 for the siltation score along with adjacent connected assets.
- ▶ 18 priority areas developed
- ▶ 6 priority areas cleaned and CCTV has part of the SWMP
- ▶ 12 areas to be cleaned and CCTV at a later date

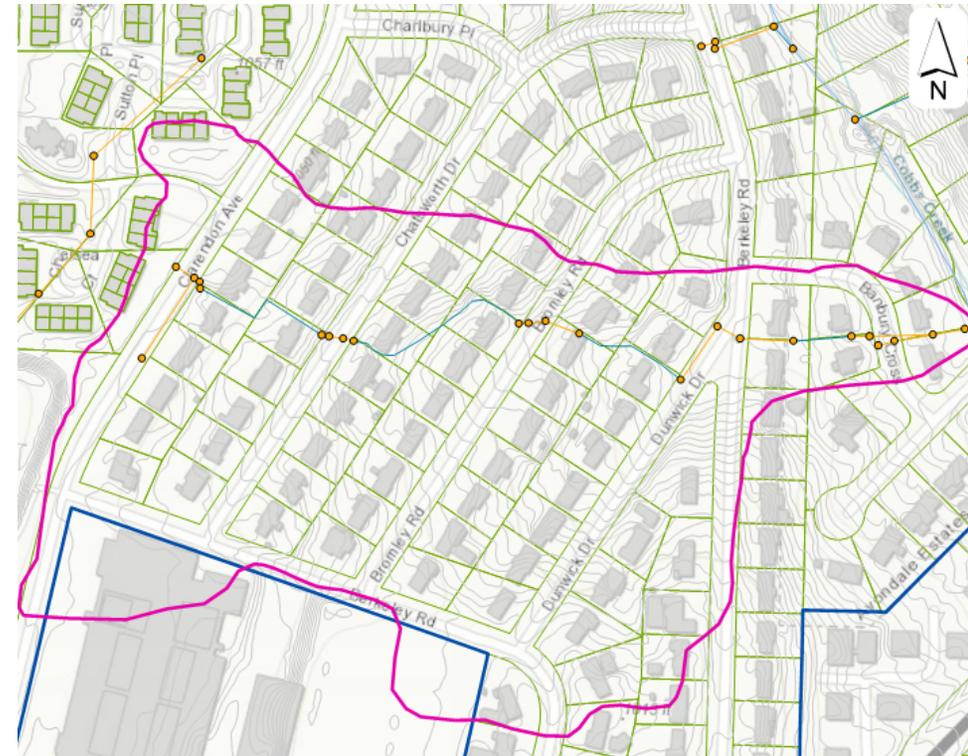
Concept #3 - Dunwick Drive Watershed

- ▶ Short term
 - ▶ Temporary repairs to prevent sink holes or other public hazards at CC-4317-C near 1133 and 1141 Dunwick Drive
 - ▶ Start a downspout disconnection program
- ▶ Long term solution
 - ▶ A watershed model to determine the drivers for flooding and possible solutions
 - ▶ Engineering design and survey

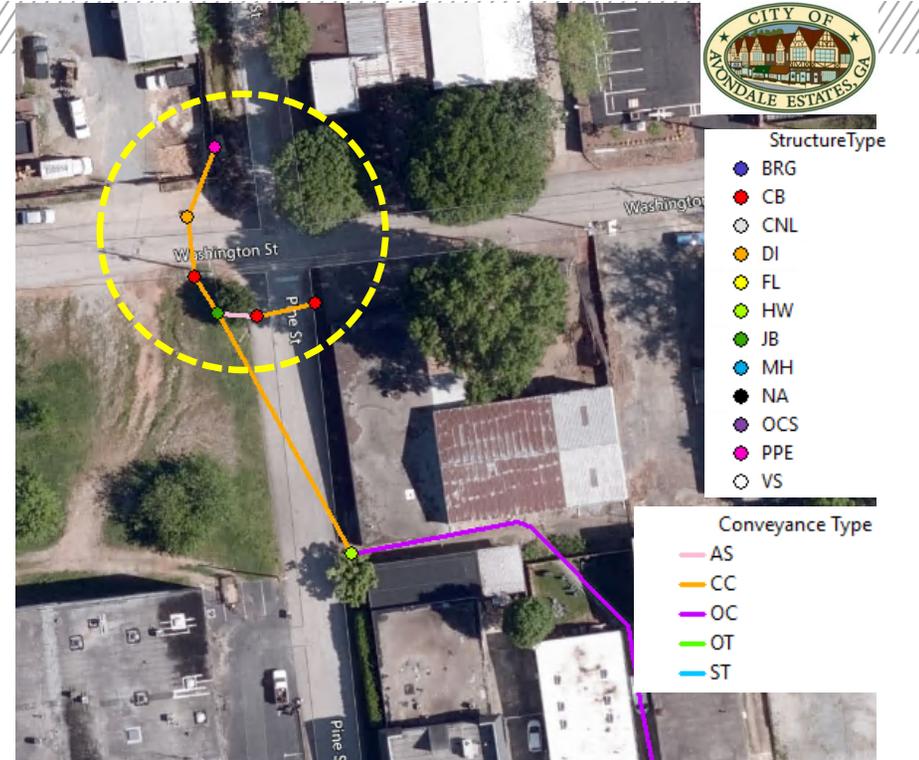
From upstream end, pipe appears collapsed since debris from cleaning process cannot move downstream

1. Replace/CIPP the pipes and maintain the current pipe size and design GI to detain stormwater volumes so that pipes may meet the desired return interval capacity
2. Develop a stormwater model for the entire drainage system flowing to the project area, determine the size of pipes needed to convey desired return interval, and confirm no downstream impacts.
