CITY OF  
**Avondale**  
ESTATES

HISTORIC PRESERVATION COMMISSION

**City of Avondale Estates  
Historic Preservation Commission  
COA Application Review\***

**March 2, 2026 HPC Meeting**

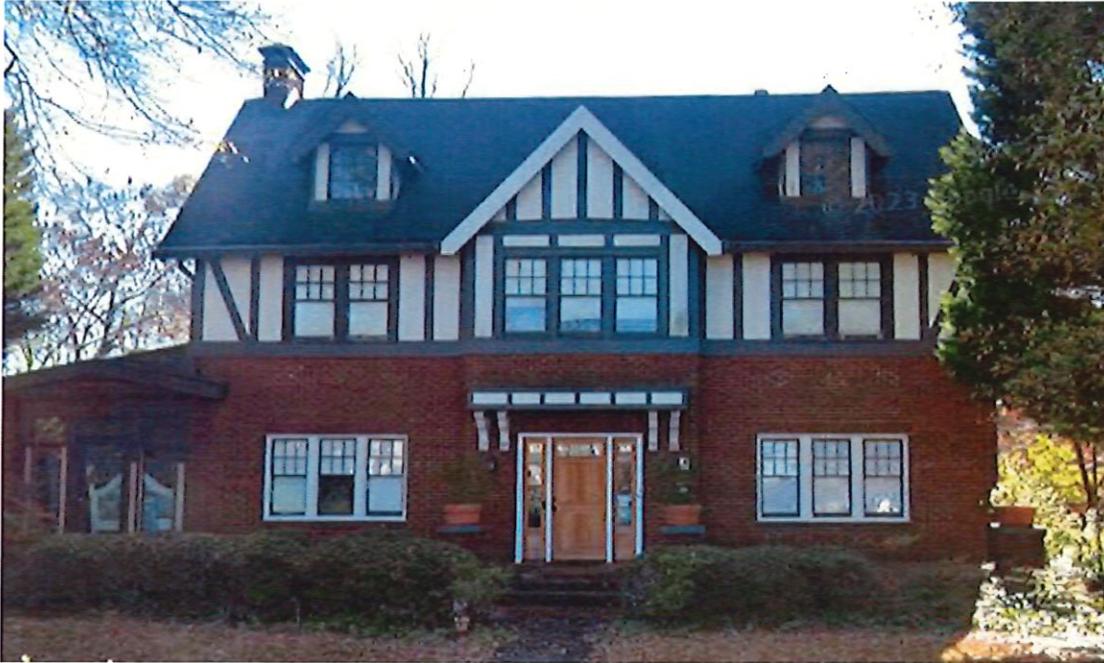
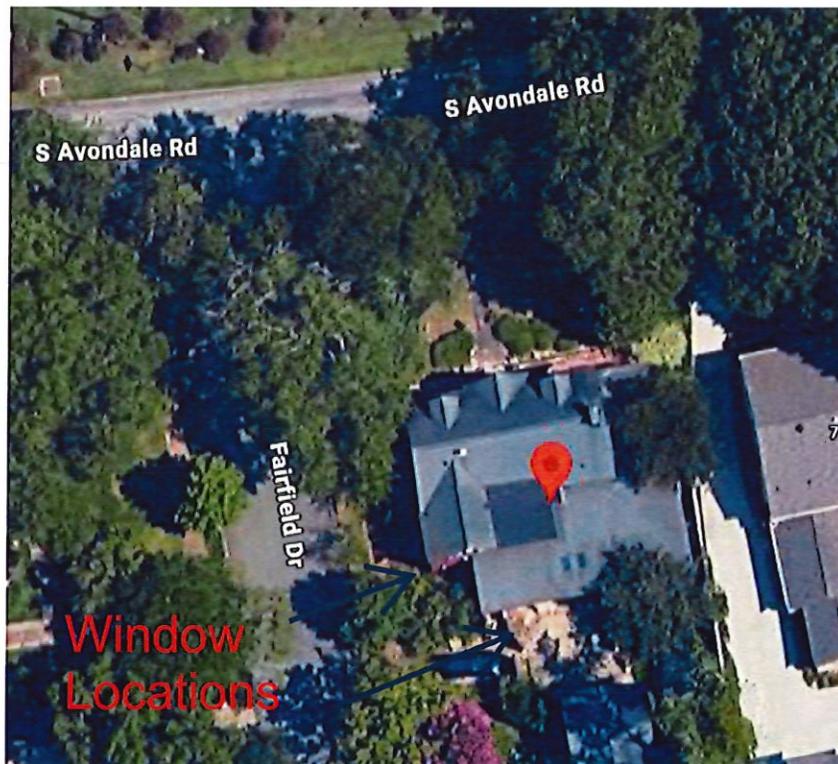
**Scope of Work:** Install five Andersen A-Series Wood clad replacement windows, same size, shape, location, and appearance as the other windows on the house. The intention is to match the appearance of the other windows on the house, to give the house uniformity.

The windows are located on the side and back.

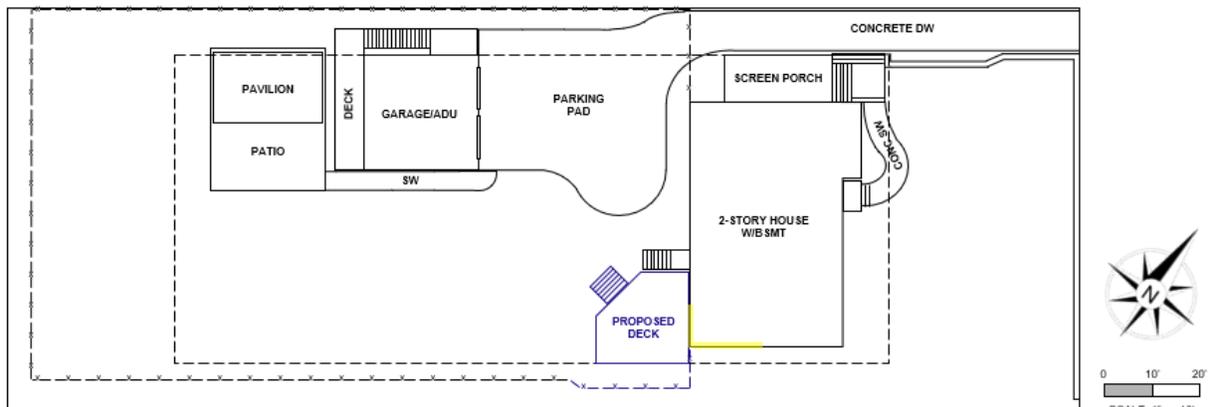
## Site plan

Mudroom exterior walls impacted by proposed work are indicated in yellow. No changes are suggested to the residence's footprint, only renovation within the existing footprint. Deck is proposed to be set back 10' from side property line as indicated in site plan. Potential shift to fence line also reflected below in blue.

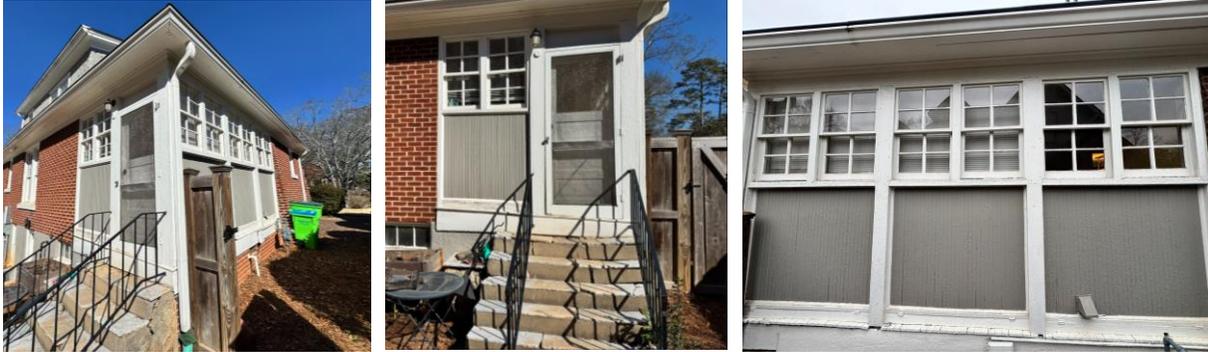
## Exterior wall finishes

Exterior walls are currently only single panels of beadboard recessed behind the face of trim-clad structural posts without any framed wall cavity. Each panel is approximately 4-5' square with three such panels along the side wall and one at the back wall. Each panel has a set of two windows above.

*From left to right: rear corner view of mudroom exterior, view from back yard, view from side yard*

Structural posts are expected to remain unchanged. Each beadboard panel, however, is proposed to be replaced with typical 2x4 framing finished with drywall on the interior and siding on the exterior. For the exterior material, we propose either horizontally lapped, tongue and groove, or panel siding. In the interest of durability and given the location of this room at the rear corner of the house, we propose using a fiber cement siding material. This will replace the single panels of beadboard with properly framed and insulated walls while retaining nearly the identical appearance of the current finishes.

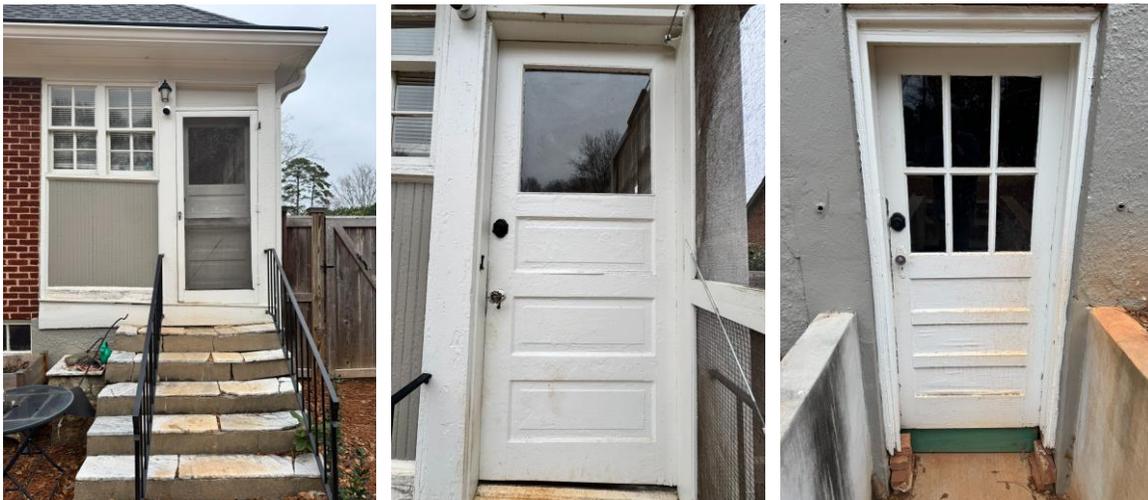
Existing rear exterior doors to mudroom and basement are both beyond repair due to state of disrepair and their irregularity in size from previously being cut to match the angled pitch of the mudroom floor and a step-over drainage pipe that previously ran along the bottom of the basement door. Existing doors are also inconsistent in design elements – e.g., raised panel vs. recessed panel, third-light vs. half-light, divided vs. non-divided light – and share no resemblance to other exterior doors on the house.

*From left to right: rear exterior wall of mudroom, zoom in on rear egress door to mudroom, rear egress door to basement*

Both doors need to be replaced with properly sized, full-height doors. We will do so with coordinating doors in both locations that will add consistency of design while improving function and security. Given both doors are exposed to the elements without cover and are exclusively rear facing, in accordance with the historical district design guidelines, we propose replacing with fiberglass doors that will add durability and security while allowing us to replicate the essential design elements. Upon replacing the mudroom door, we propose slightly shifting its location along the same wall, swapping its placement with the window/panel segment to its side. This small change will allow the door to align with the interior door and improve the flow of foot traffic and usefulness of the space while making no meaningful change to the overall design of the room.

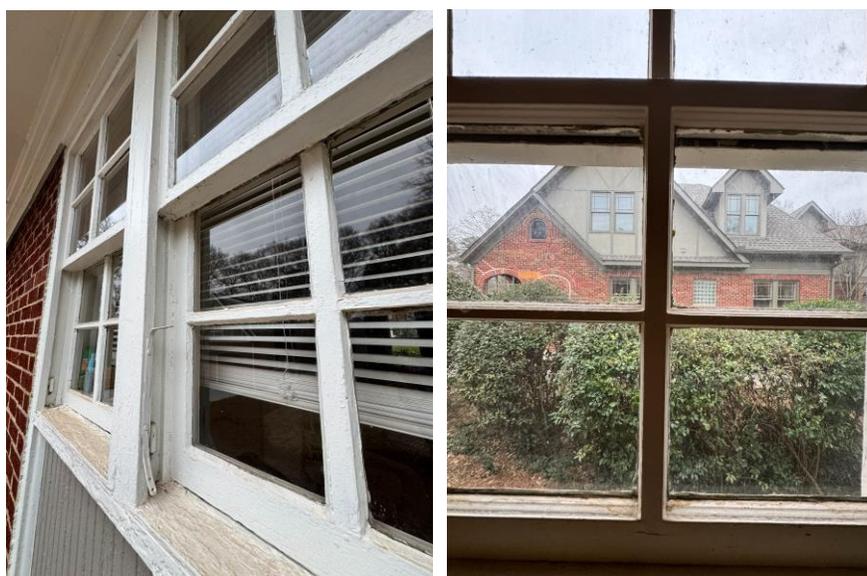
Existing windows within the mudroom are entirely inoperable, have several broken / damaged panes, have areas with significant rot, and the type of window and design elements of these specific windows are inconsistent with the historical windows of the house, also consistent with the potential that this room was a porch that was later finished in. Notably, these windows appear to be spring balanced rather than the historical weighted windows found in the rest of the 1926 house and are also inconsistent with the muntin design and non-divided lower sashes of all other windows on the house.

*From left to right: exterior view of mudroom windows, interior view of mudroom windows*

Windows need to be removed and replaced as part of the re-framing of the mudroom exterior walls described above. Given the inoperability, disrepair, and the fact that these windows are inconsistent with the historical windows elsewhere in the house, we propose replacing with architectural grade windows customized to closely replicate the specific design elements of the original windows across the house. Specifically, we propose using the same customized Andersen windows and specs that were recently approved by the HPC and installed for our second floor in prior renovations. These windows will match the following specs of the house: double hung, equal sash, divided upper sash and non-divided lower sash,  $\frac{3}{4}$ " muntin with fully divided (separator between panes) double pane glass, wood construction, etc. Design drawings are included in the images below.

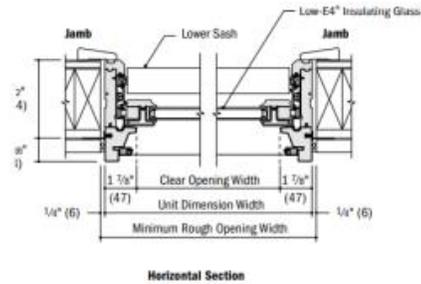
**Grille Bar Widths & Pattern**

Design photos for proposed windows (exact same specs as windows replaced elsewhere in house)

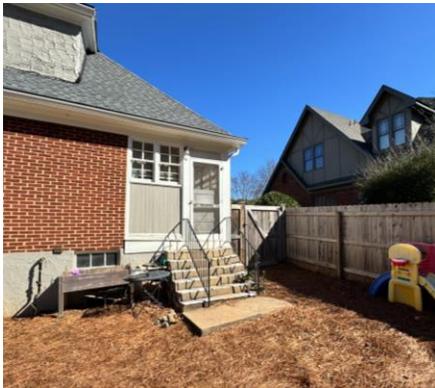
Existing entry to the rear mudroom egress door is via a set of masonry stairs with no landing at the top. Existing stairs are in disrepair and beginning to settle and come apart at mortared joints.

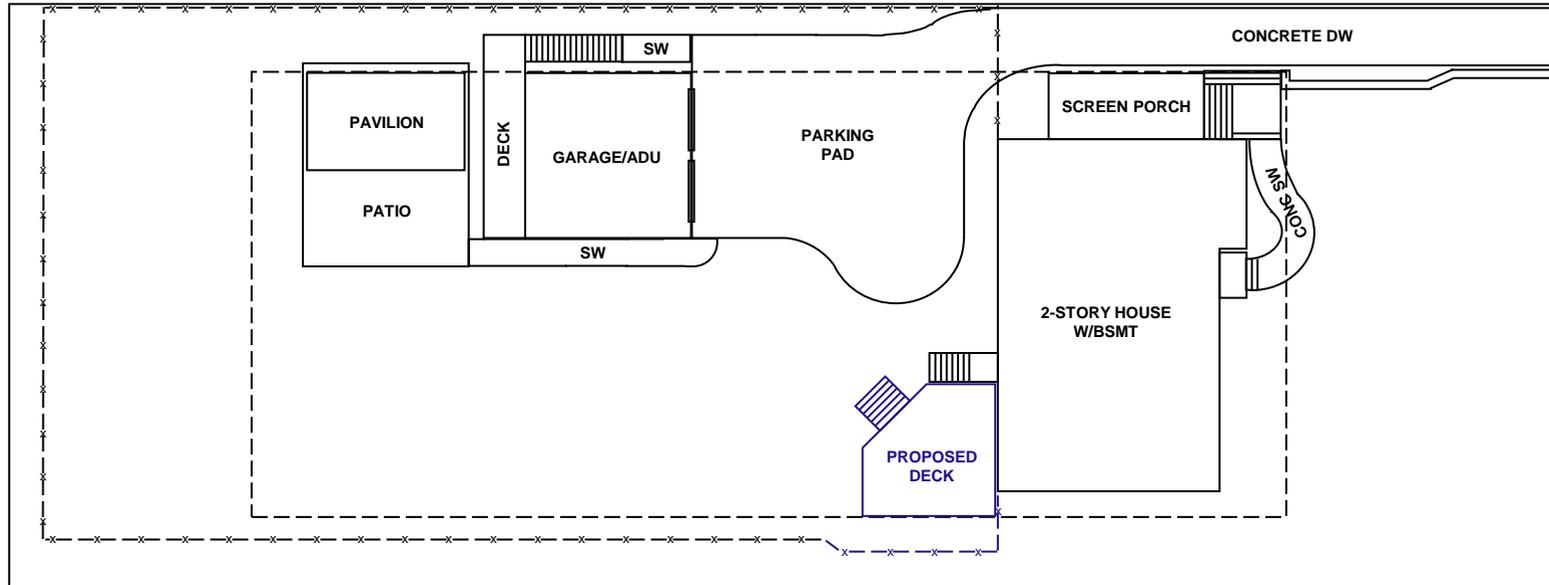
We propose replacing existing stairs with a rear deck off the mudroom of approximately 20'x20'. Rear door is currently ~36" above ground level, which will serve as the expected height of the deck (though higher from ground away from house according to minorly sloped grade). Deck will be set back 10' from the side property line given its height above 30". We plan to use the same materials for this deck as the other deck built last year at the property with a high grade and durable composite material for deck boards and railing (MoistureShield Meridian decking and TimberTech composite railing).
